**PACFISH Buffer and
Temporary Road Monitoring and
Miscellaneous Timber Sale
Observations Report**

**Lochsa/Powell Districts
Nez Perce-Clearwater National Forests**

December, 2016

Prepared by Karen Smith, Central Zone Fisheries Biologist

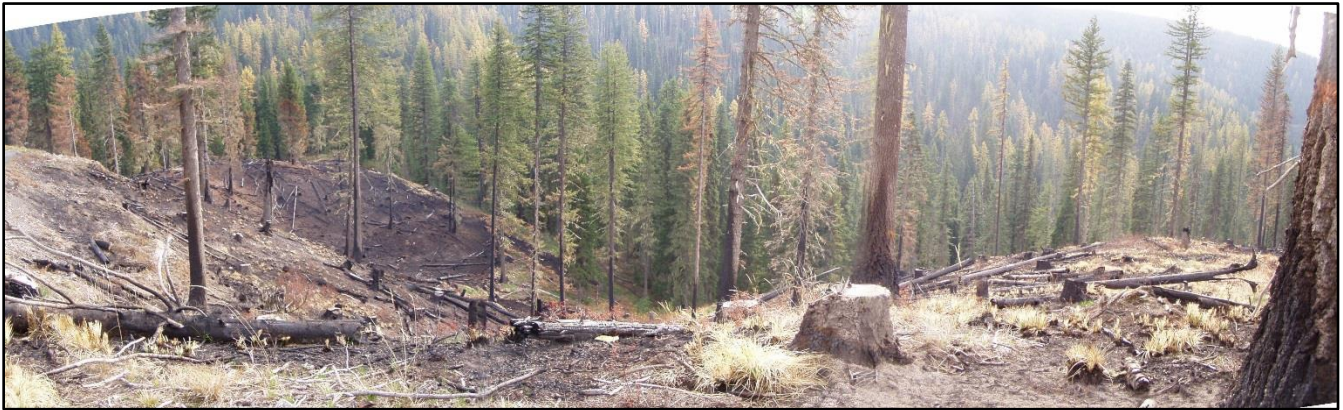
Photo 1. Knoll Creek Bugs Unit 6- RHCA on downhill edge of unit

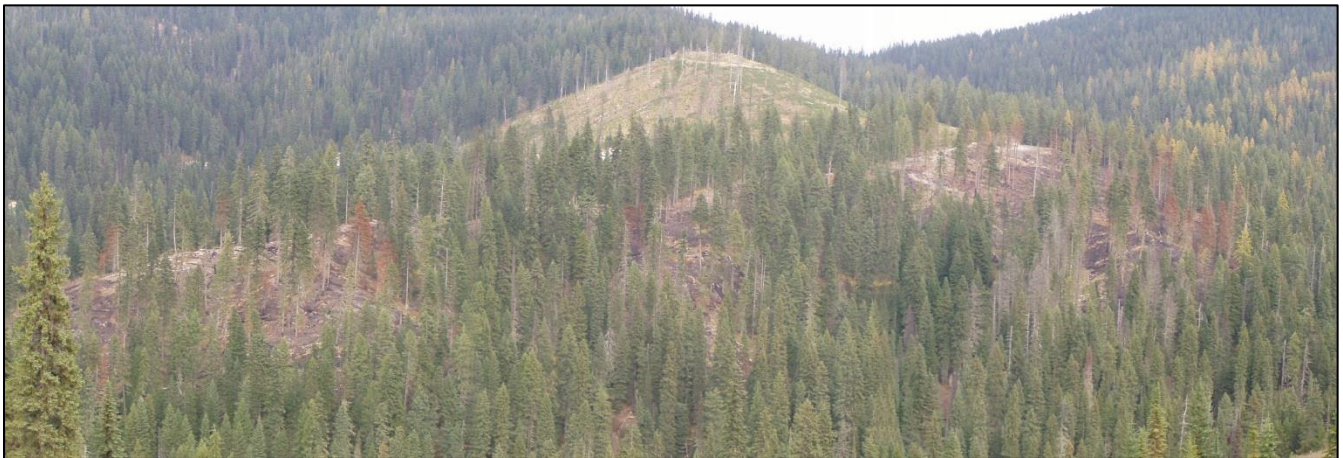
Photo 2. Knoll Creek Bugs Unit 6 with RHCAs evident.

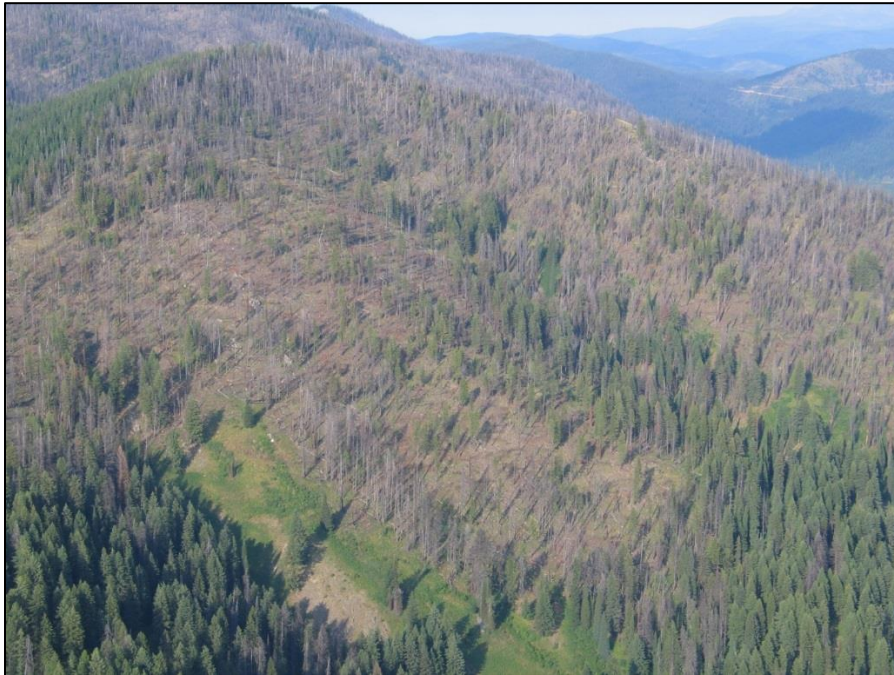
Photo 3. Unit 1 post-harvest.

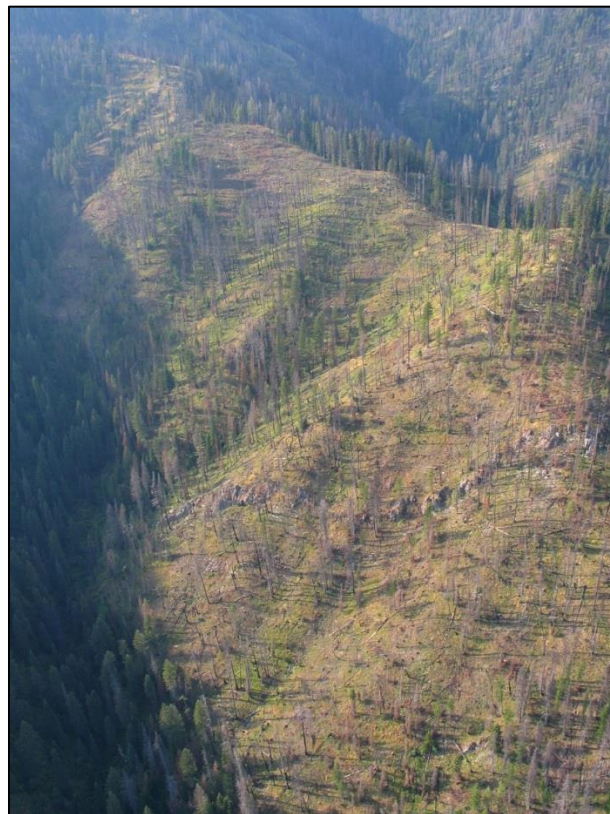
Photo 4. Unit 3 post-harvest

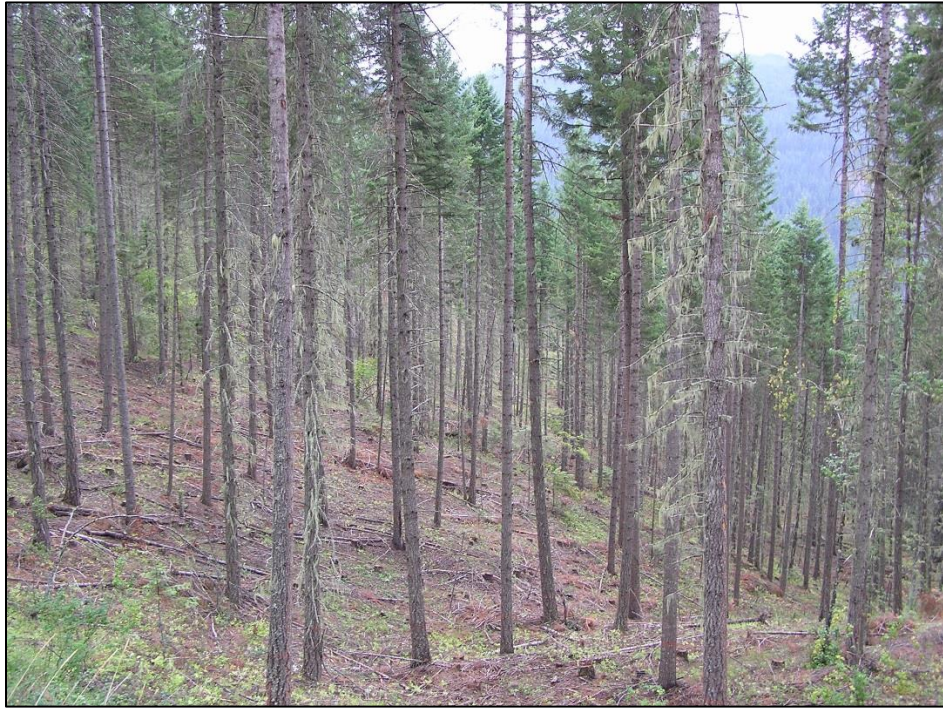
Photo 5. Commercial thin unit.

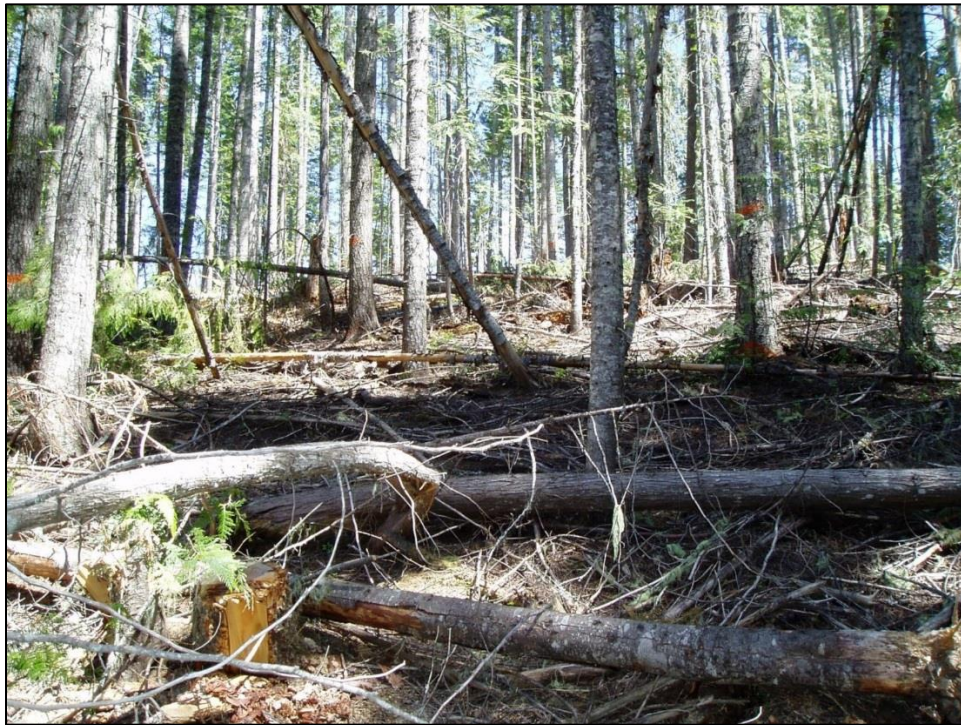
Photo 6. Post-harvest. Tractor yarding occurred over snow during winter.

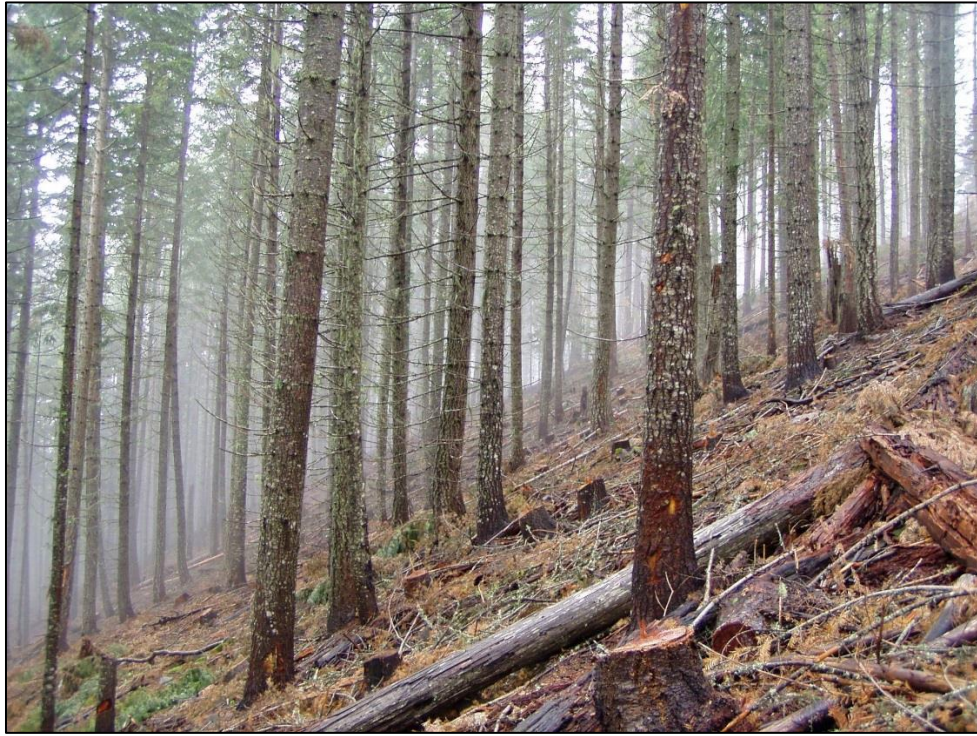
Photo 7. Thinned area

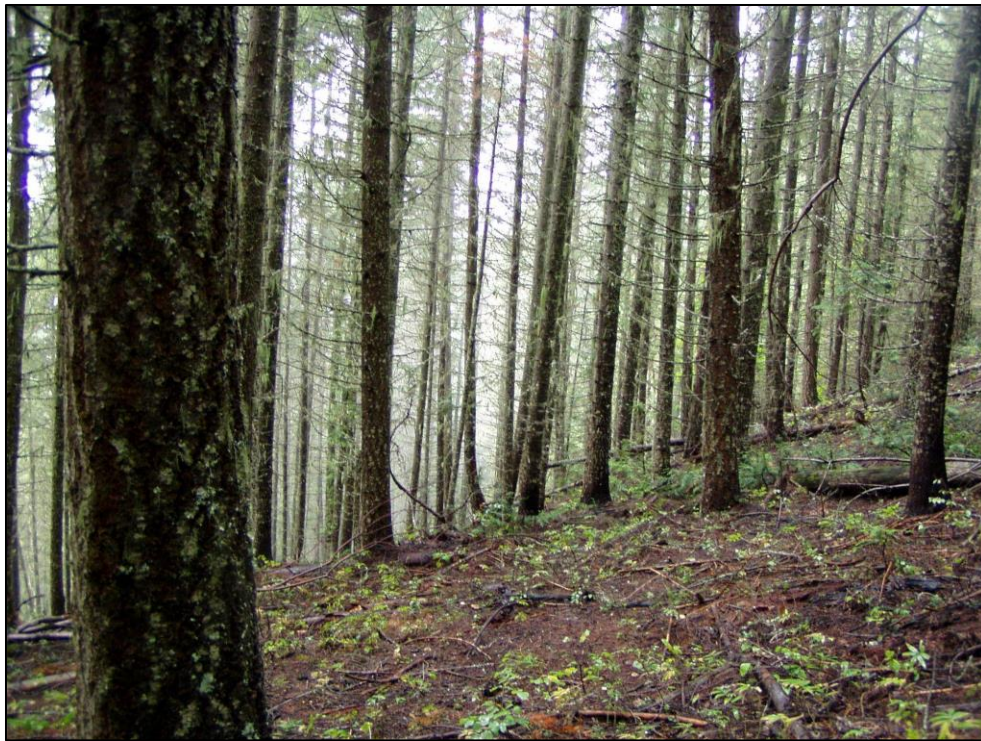
Photo 8. Nearby unthinned area

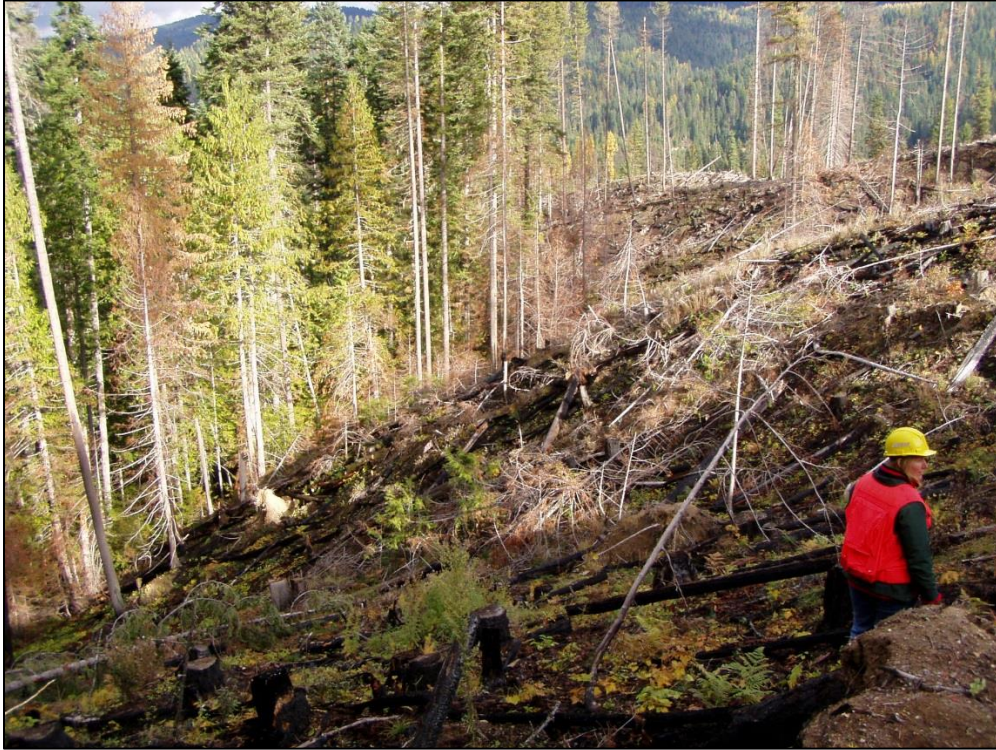
Photo 12. Buffer on downhill edge of Unit 6, 2006.

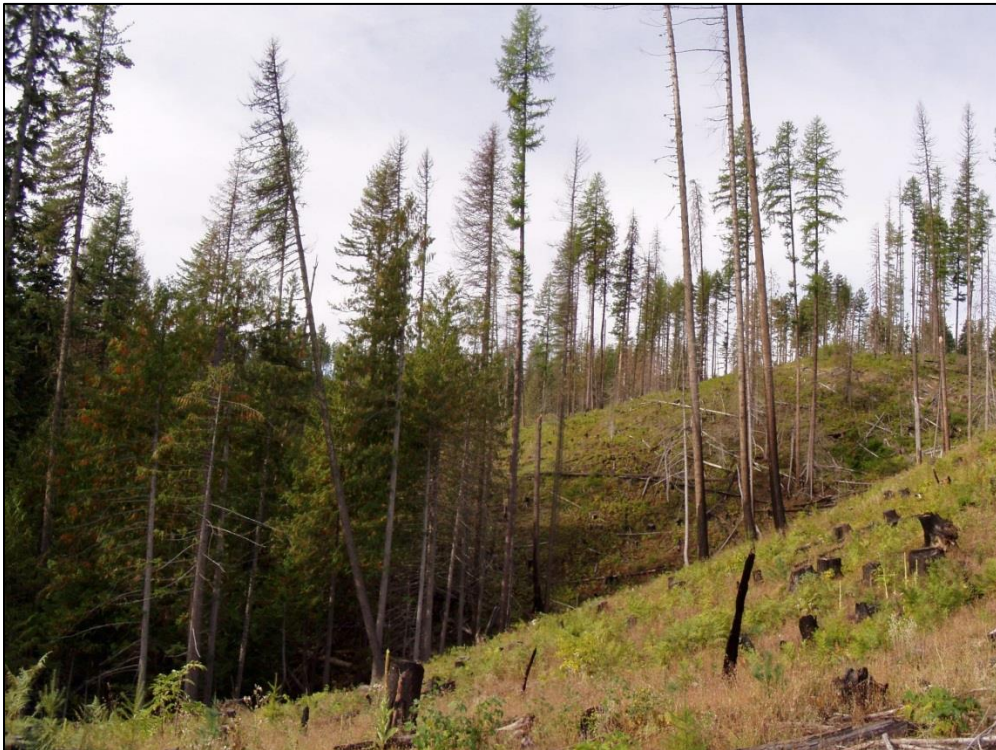
Photo 13. Unit 6 in 2008, two years after review.

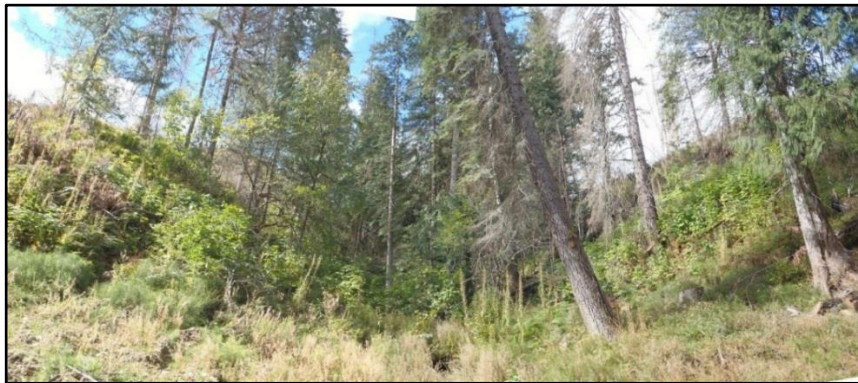
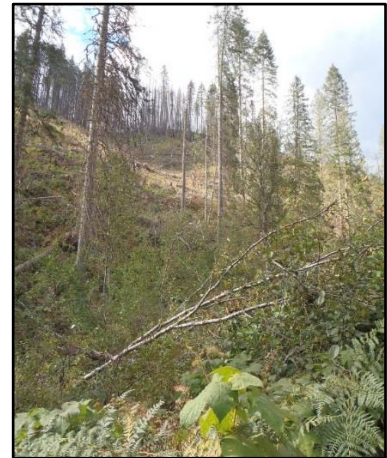
Photos 14 and 15. IDL buffer on Burnt Creek (left) and private lands on Elk City Creek (right).

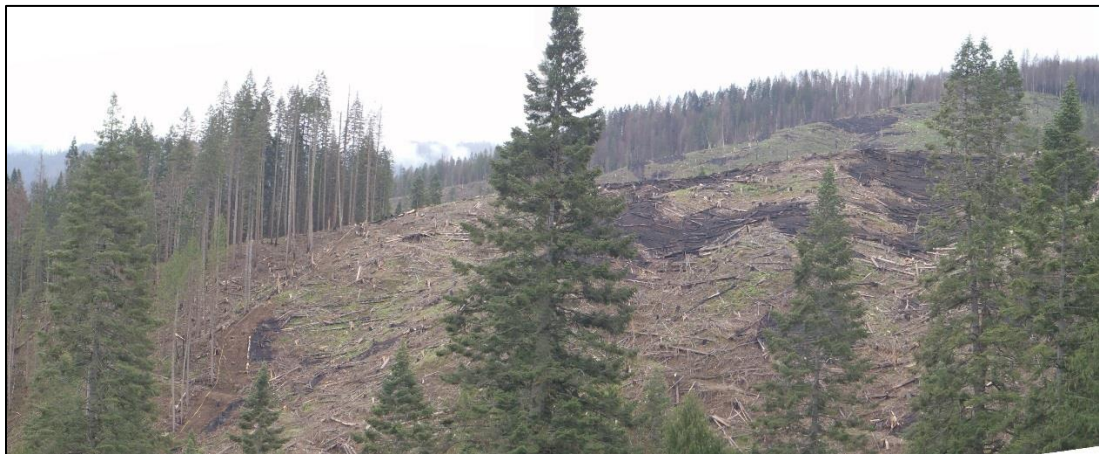
Photo 16. Abundant surface material after IDL harvest and burning, 2016

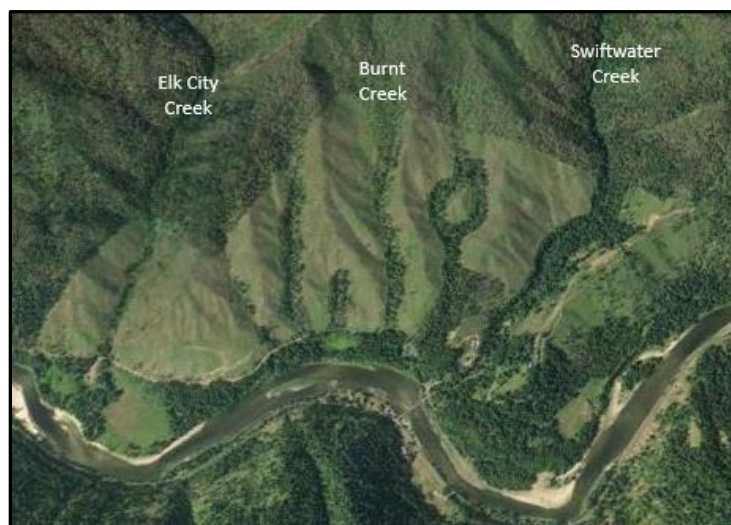
Photo 17. Google Earth view of streamside buffers on IDL and private lands.

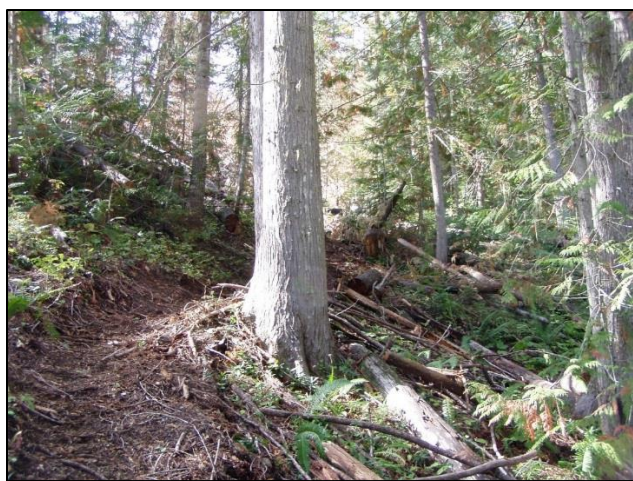
The RHCAs themselves are comprised of thick vegetation and downed woody material which act as a virtually impenetrable, filtering source for overland sediment flow (Photos 18 and 19). It is extremely unlikely that sediment would be delivered to streams through the RHCAs as a result. The results of this monitoring are consistent with local BMP monitoring on the Clearwater National Forest which has occurred since 1990. Between 1990 and 2008, the Forest had BMP implementation and effectiveness rates of 97% or greater (USDA, 2009). BMP audits on state and private forestry lands also had good results as well even though buffer widths were typically half or less the width of PACFISH RHCAs (Cristan et al 2014; Sugden et al 2012; Lakel 2010; Lee 2004).

Photo 18. RHCA interior (with fireline).

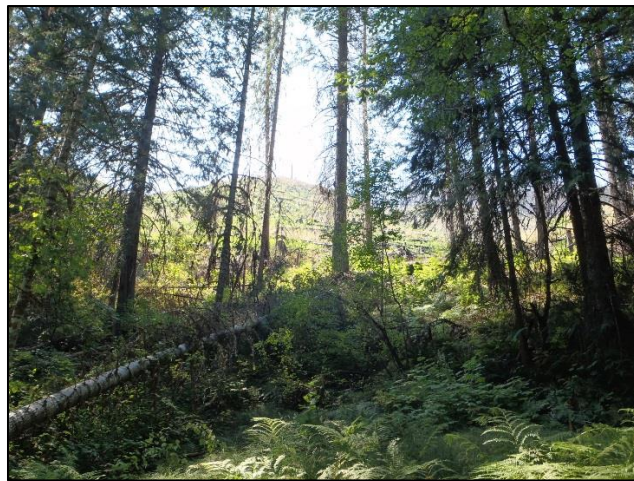
Photo 19. IDL buffer interior (Swiftwater Cr.).

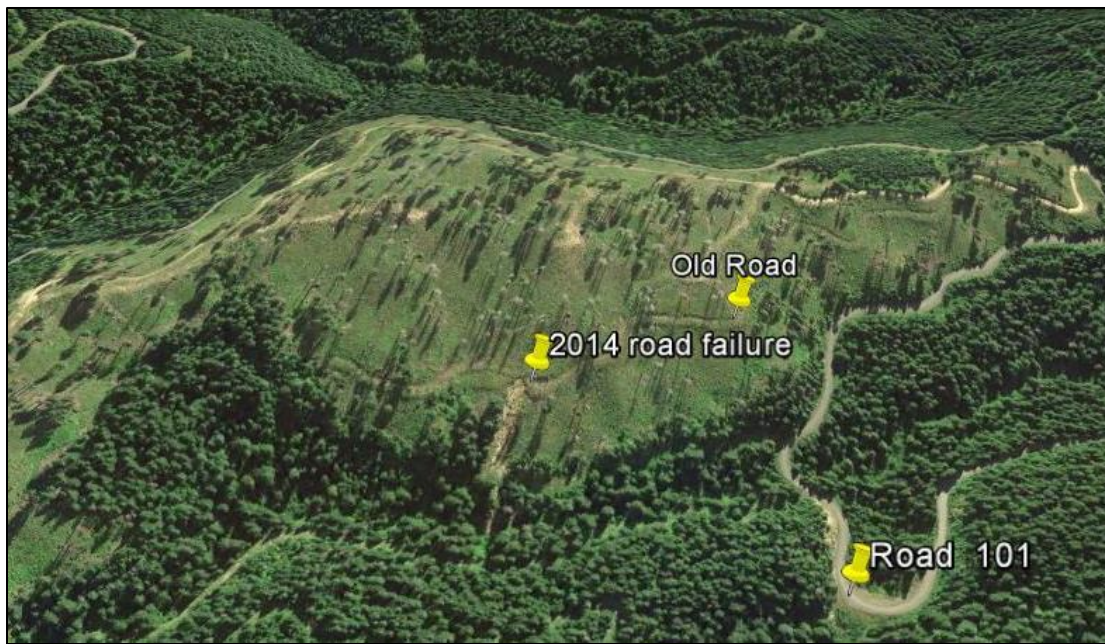
PACFISH requires the buffering of verified landslide prone areas. Landslides are necessary for the development of aquatic habitat in that they can deposit large wood and gravel/cobble substrates to streams. These provide critical elements in the formation and maintenance habitat for all aquatic organisms (Luce et al 2012; Bisson et al 2009; Lassettre and Harris 2001). One landslide was observed during 2014 surveys and was associated with a previously stored road which was mostly recontoured (Photo 19). It was not used for the harvest activities and was not on a verified landslide prone area. The slide deposited sediment and some wood into the headwaters of Pete King Creek.

Photo 19. Previously stored road failure in Polar Ice Unit 8.

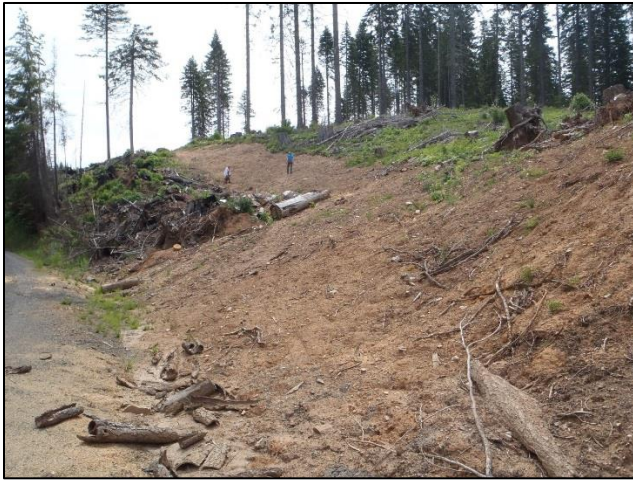
No erosion was observed on 12 of the 13 surveyed roads. Limited erosion was noted on one road (Yakus Unit 9, harvested in 2008) and none of the sediment was delivered to RHCAs or streams. The sediment was delivered into a roadside ditch where it was diverted through a cross drain culvert away from live water. The road was constructed on a side slope and was full recontoured; however, no woody material was placed on it as it was used as a fire break during broadcast burning activities. Rill erosion was noted on the road surface, some of which travelled down the slope and into the adjacent permanent road ditchline (Photos 20 and 21).

Photo 20. Temporary road, Yakus Unit 9, no wood.

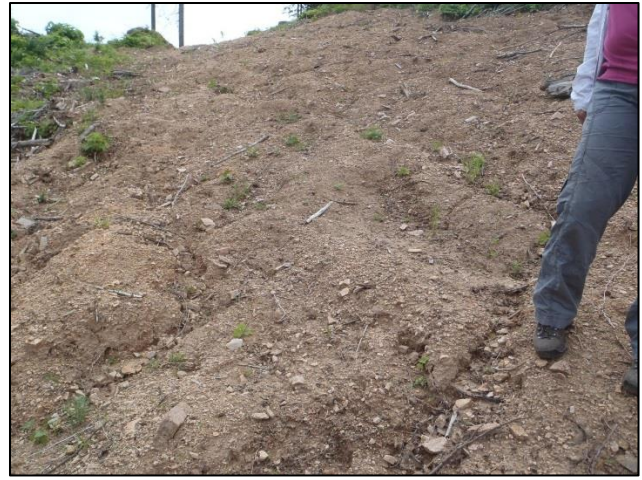
Photo 21. Erosion on temporary road.

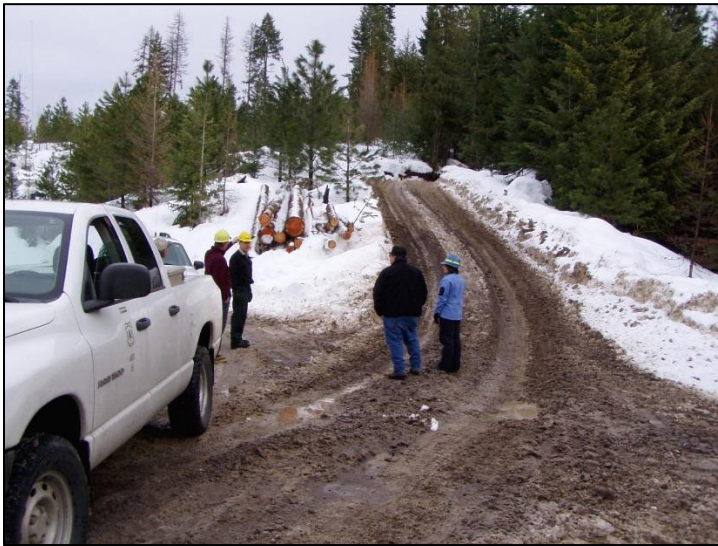
Photo 22. Temporary road in used, winter 2009 (White White Unit 32).

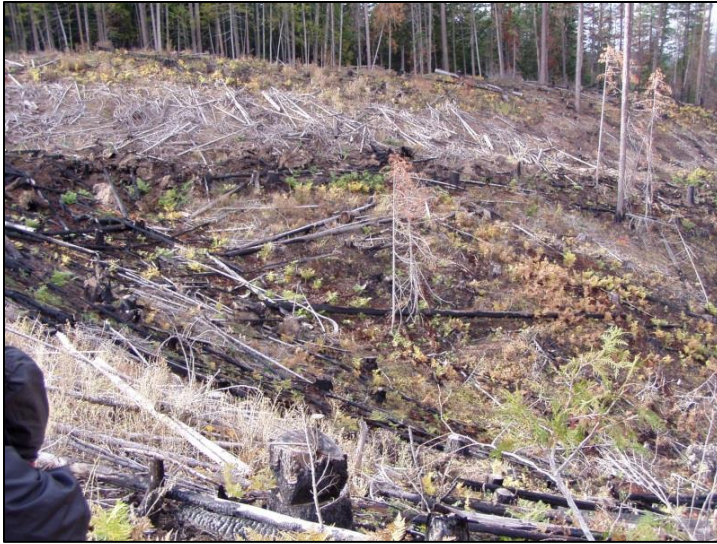
Photo 23. Brick Trout Unit 6 temporary road, 2006.

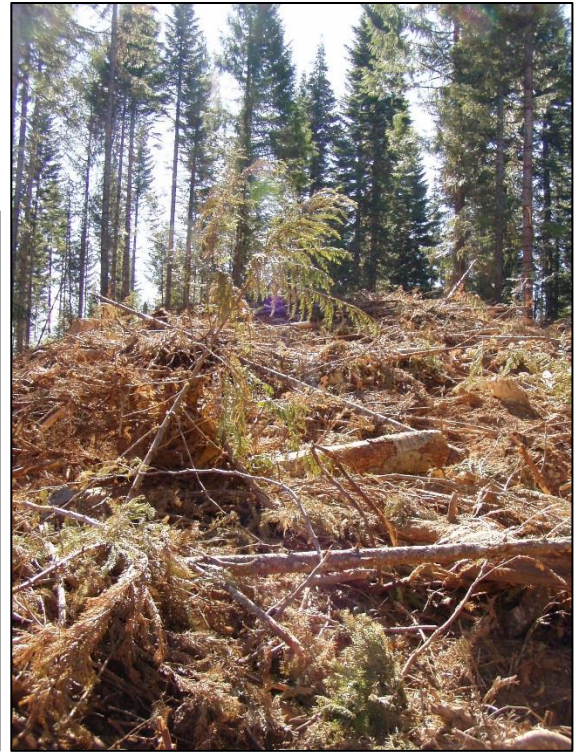
Photo 24. Johnson Thin temporary road, 2010.

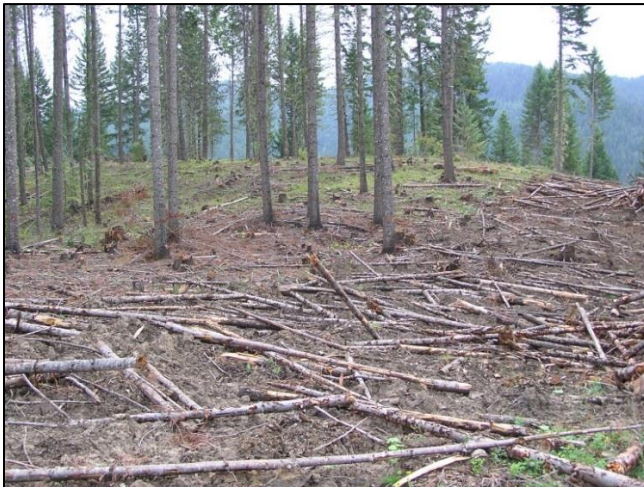
Photo 25. Polar Ice Unit 10 temporary road, 2013.

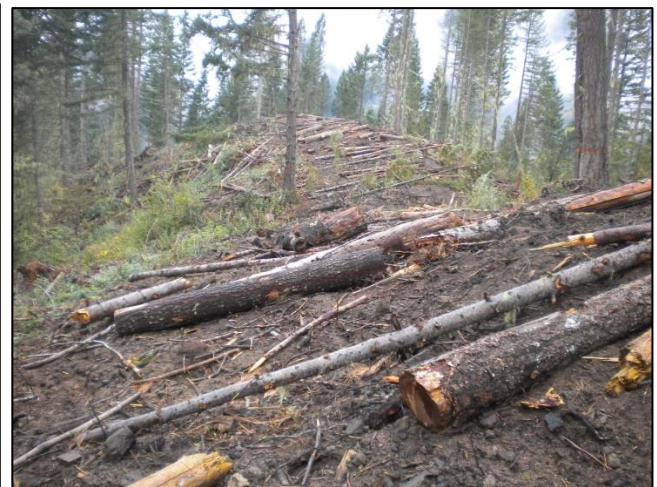
Photo 26. Saddle Camp temporary road, 2015.
